RLOP F-1550 Furnace Elbow Leak and Fire

Loss# 23111 Inv# 14914

Hydroprocessing Division,
RLOP, HNC Plant

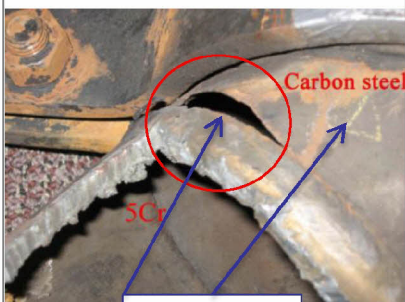
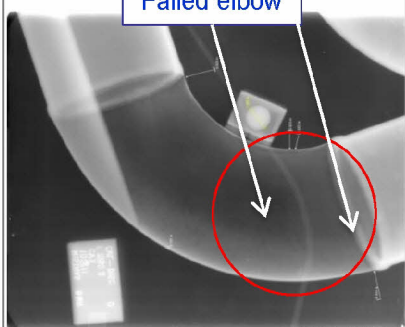
Carbon steel elbow in 5Cr
Furnace Coil

- 1) While sulfur concentration, pressure, and temperature have not changed in a decade, the rate of sulfidation corrosion for this carbon steel elbow increased and resulted in this failure.
- 2) The damage could have been much worse if the elbow had failed prior to pulling feed for the shut down.

- 1) Update the Retroactive PMI procedure to include all furnaces.
- 2) Update inspection plans to perform a one-time retroactive PMI inspection (at the next inspection activity) on all alloy furnaces (in the Richmond refinery) where similar PMI inspection data has not already been fully documented.
